**Department of Veteran Affairs
Omaha VA Hospitals Facility Condition Comparison**

Omaha, Nebraska

Omaha VA Hospitals Facility Condition Comparison

January 16, 2015

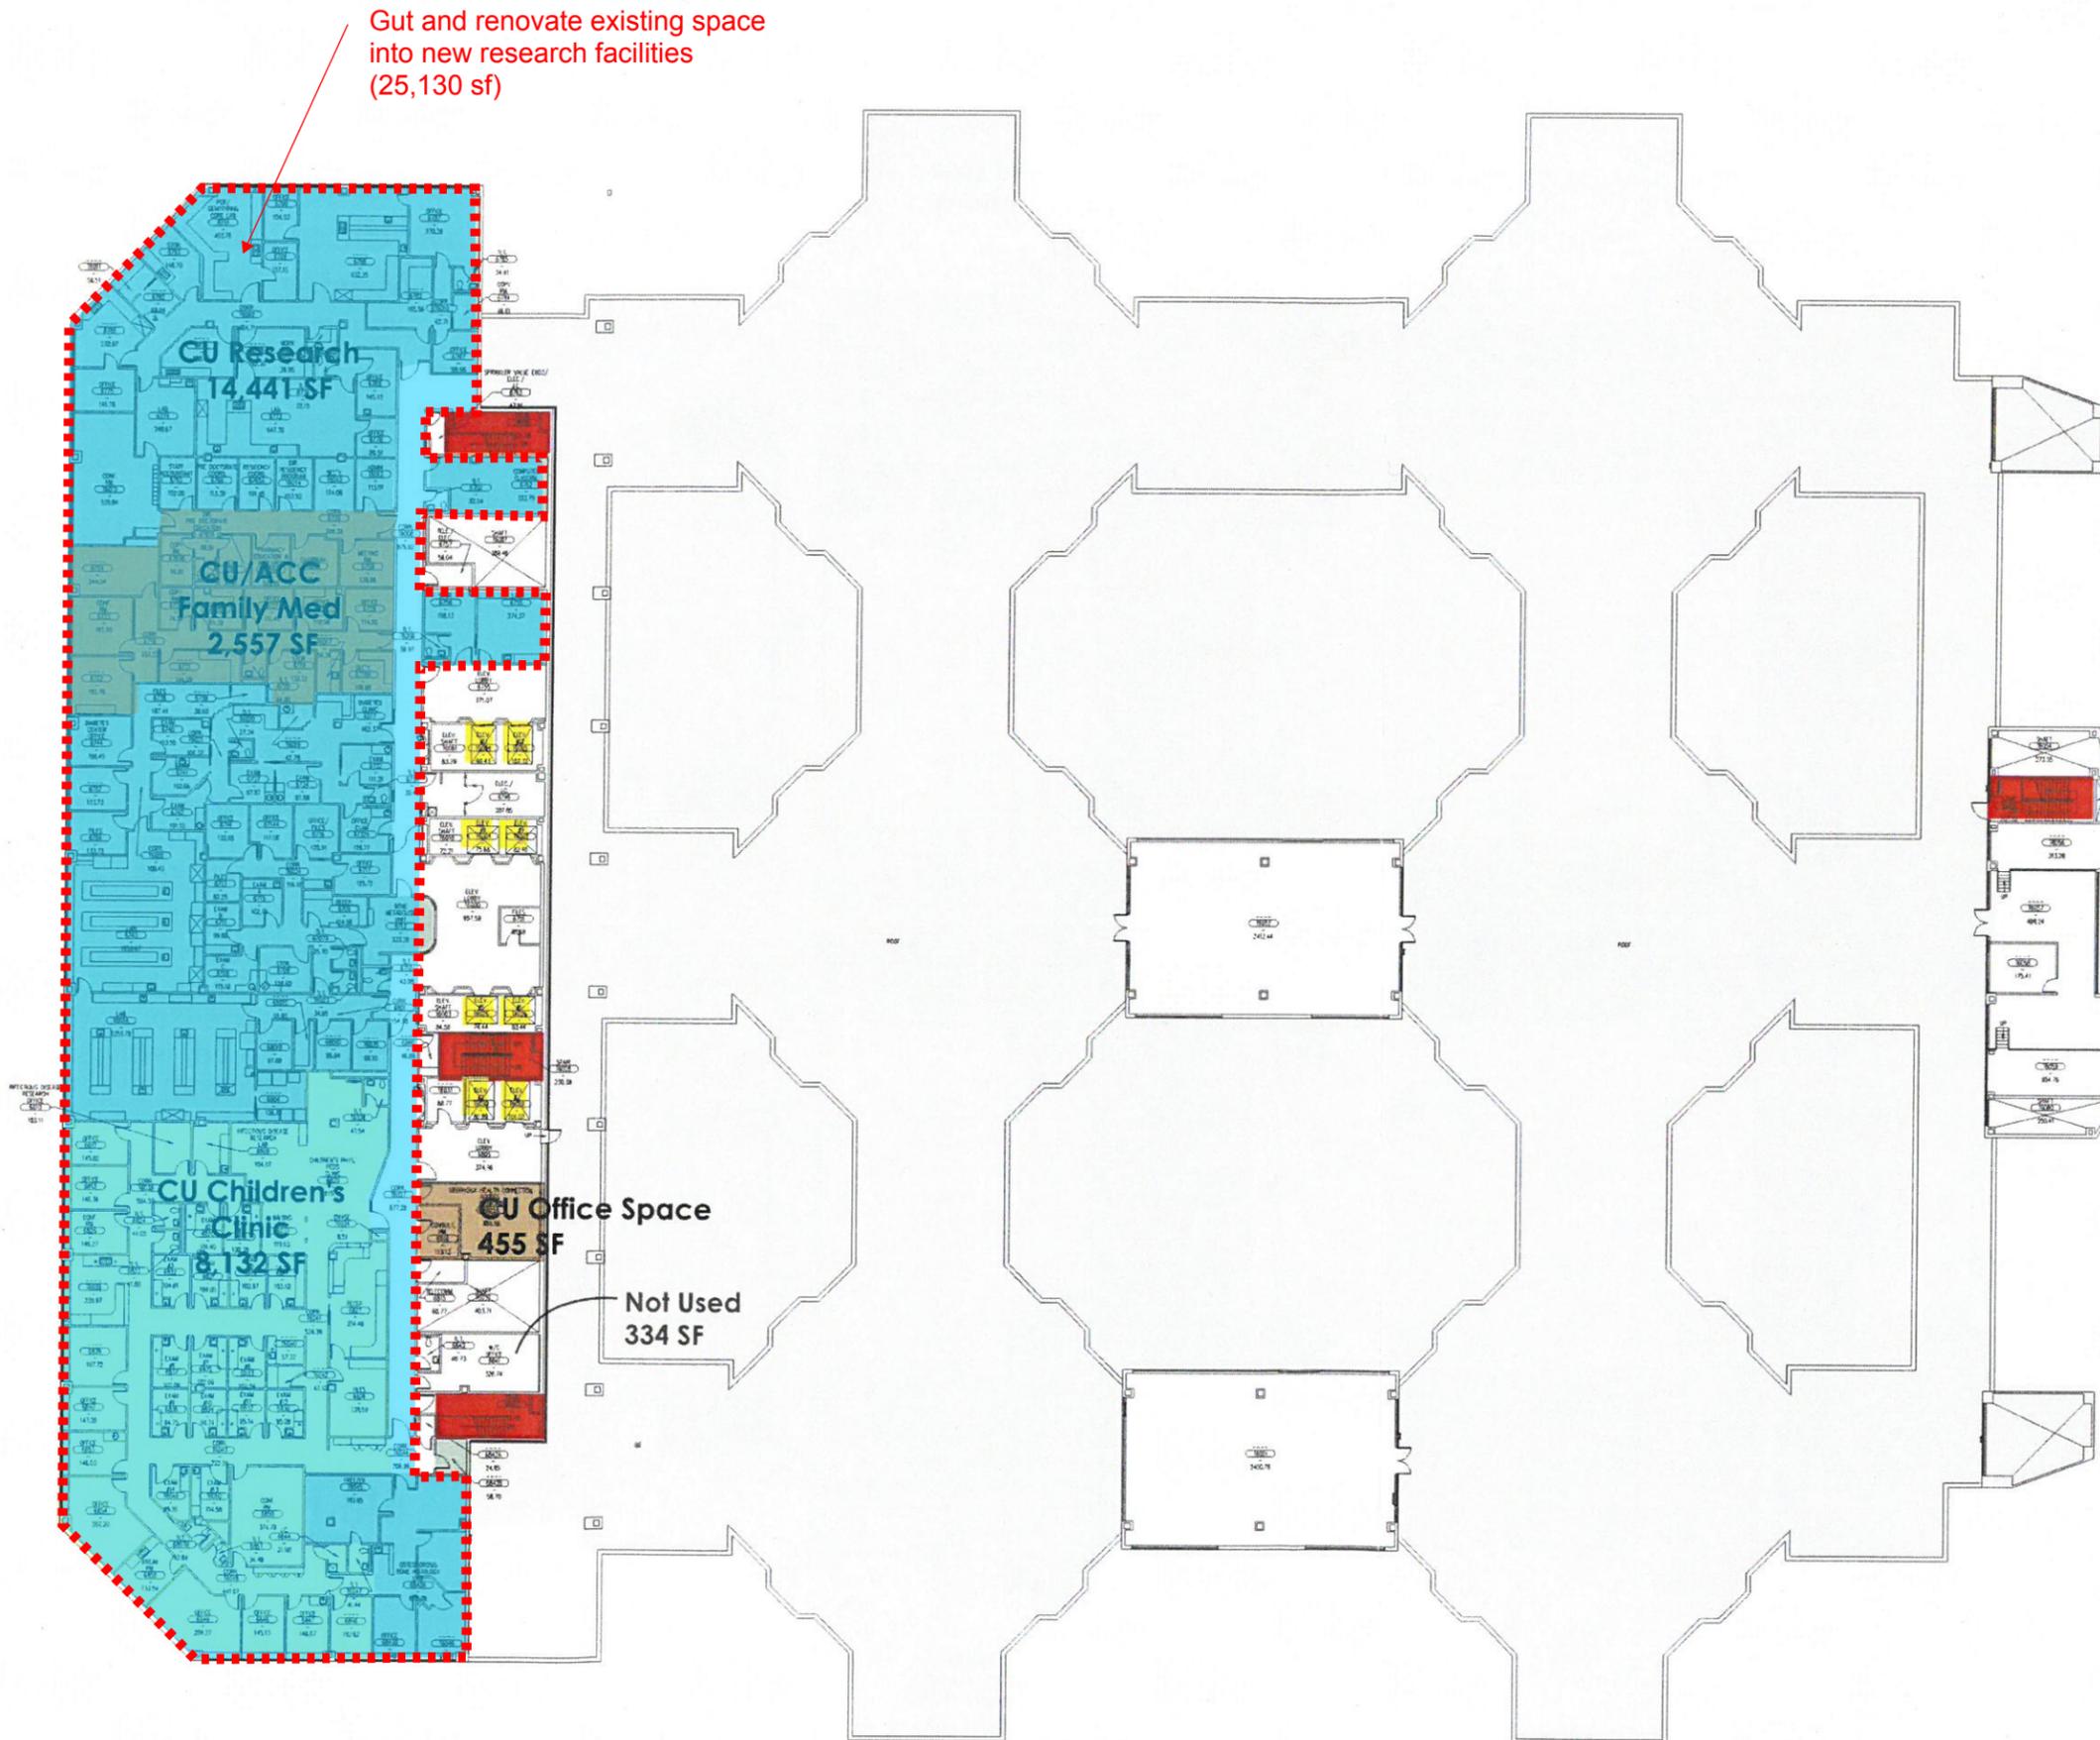
Gut and renovate existing space
into new research facilities
(25,130 sf)

CU Research	14,441 SF
CU/ACC Family Med	2,557 SF
CU Children's Clinic	8,132 SF
CU Office Space	455 SF
Total	25,585 SF
Misc. Circulation, Mech. & Exterior Wall	16,044 SF
Total Gross	41,629 SF

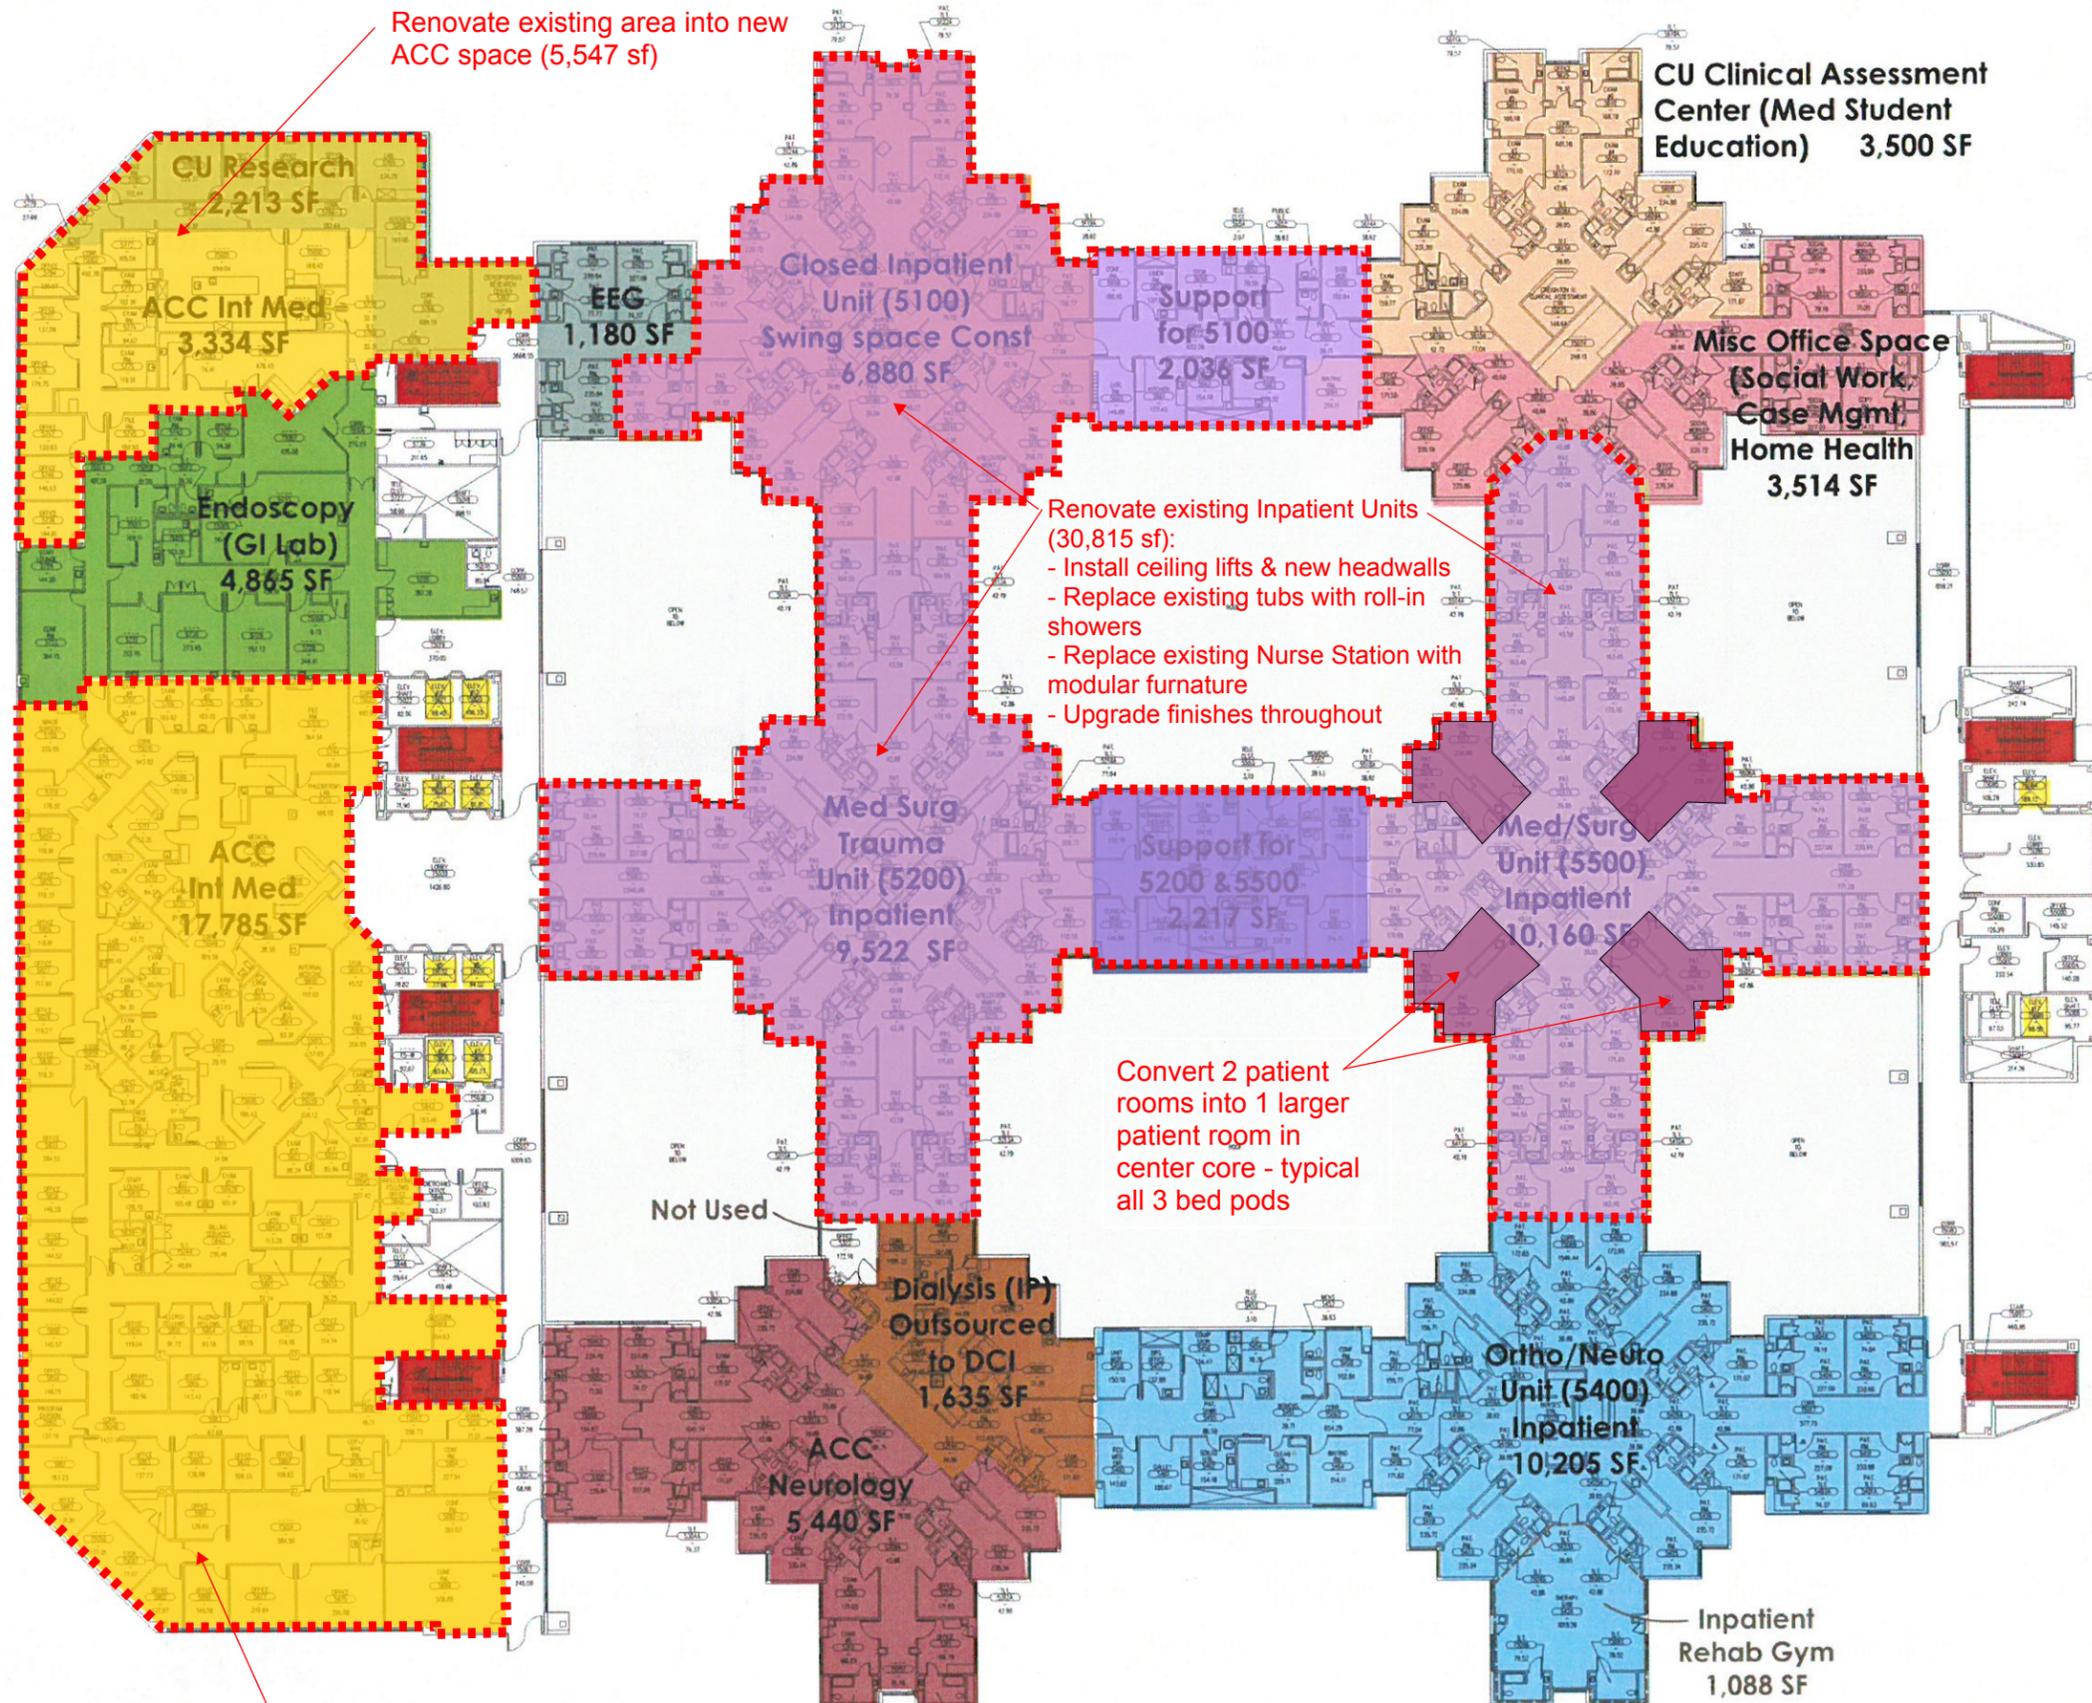
CU Research	2,213 SF
ACC Int Med	3,334 SF
Endoscopy (GI Lab)	4,865 SF
ACC Int Med	17,785 SF
EEG	1,180 SF
Closed Inpatient Unit (5100)	
Swing space Const	6,880 SF
Med Surg Trauma Unit (5200) Inpatient	9,522 SF
ACC Neurology	5,440 SF
Dialysis (IP)	
Outsourced to DCI	1,635 SF
Support for 5100	2,036 SF
Support for 5200 & 5500	2,217 SF
CU Clinical Assessment Center (Med Student Education)	3,500 SF
Misc Office Space (Social Work, Case Mgmt, Home Health)	3,514 SF
Med/Surg Unit (5500) Inpatient	10,160 SF
Ortho/Neuro Unit (5400) Inpatient	10,205 SF

Total 84,486 SF
Misc. Circulation, Mech. & Exterior Wall **20,315 SF**
Total Gross 104,801 SF

Renovate existing Inpatient Units (30,815 sf):
- Install ceiling lifts & new headwalls
- Replace existing tubs with roll-in showers
- Replace existing Nurse Station with modular furniture
- Upgrade finishes throughout

Gut & renovate existing clinic and academic offices into new ACC space (17,785 sf)

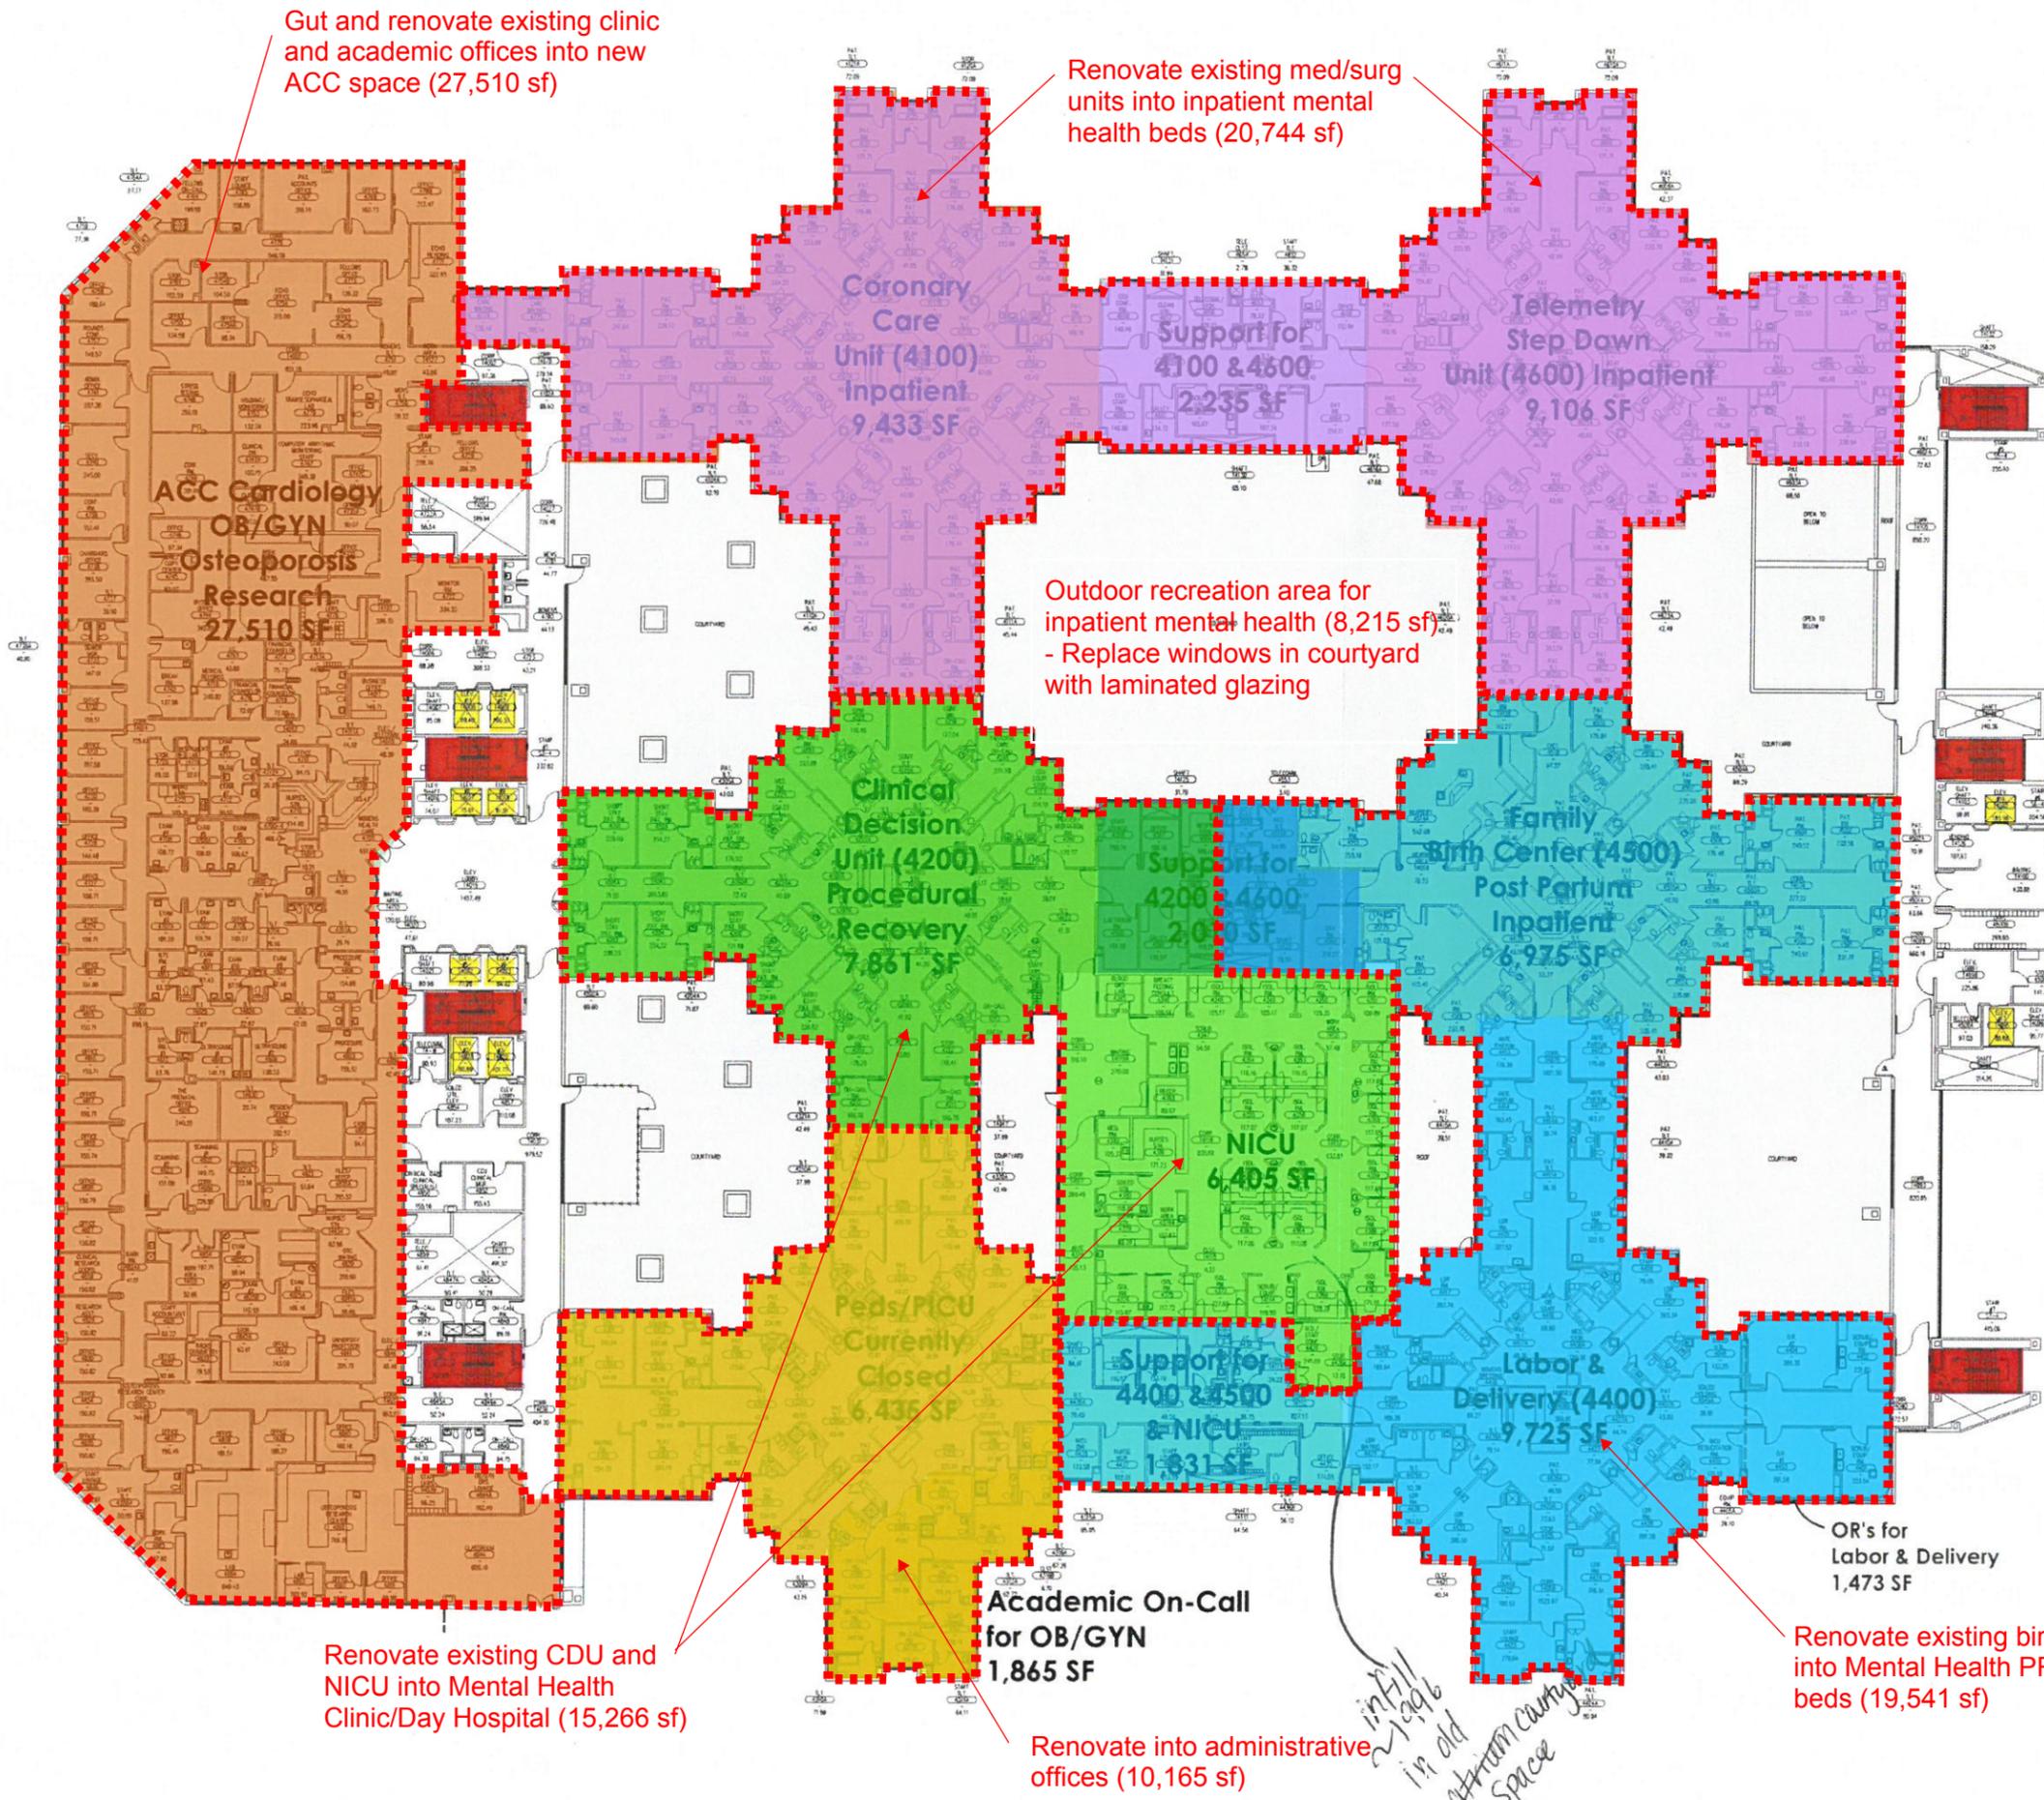
- ACC Cardiology OB/GYN Osteoporosis Research 27,510 SF
- Coronary Care Unit (4100) Inpatient 9,433 SF
- Clinical Decision Unit (4200) Procedural Recovery 7,861 SF
- Peds/PICU Currently Closed 6,435 SF
- Support for 4100 & 4600 2,235 SF
- Support for 4200 & 4600 2,010 SF
- NICU 6,405 SF
- Academic On-Call for OB/GYN 1,865 SF
- Support for 4400 & 4500 & NICU 1,831 SF
- Telemetry Step Down Unit (4600) Inpatient 9,106 SF
- Family Birth Center (4500) Post Partum Inpatient 6,975 SF
- Labor & Delivery (4400) 9,725 SF

Total 91,391 SF
Misc. Circulation, Mech. & Exterior Wall **19,756 SF**
Total Gross 111,147 SF

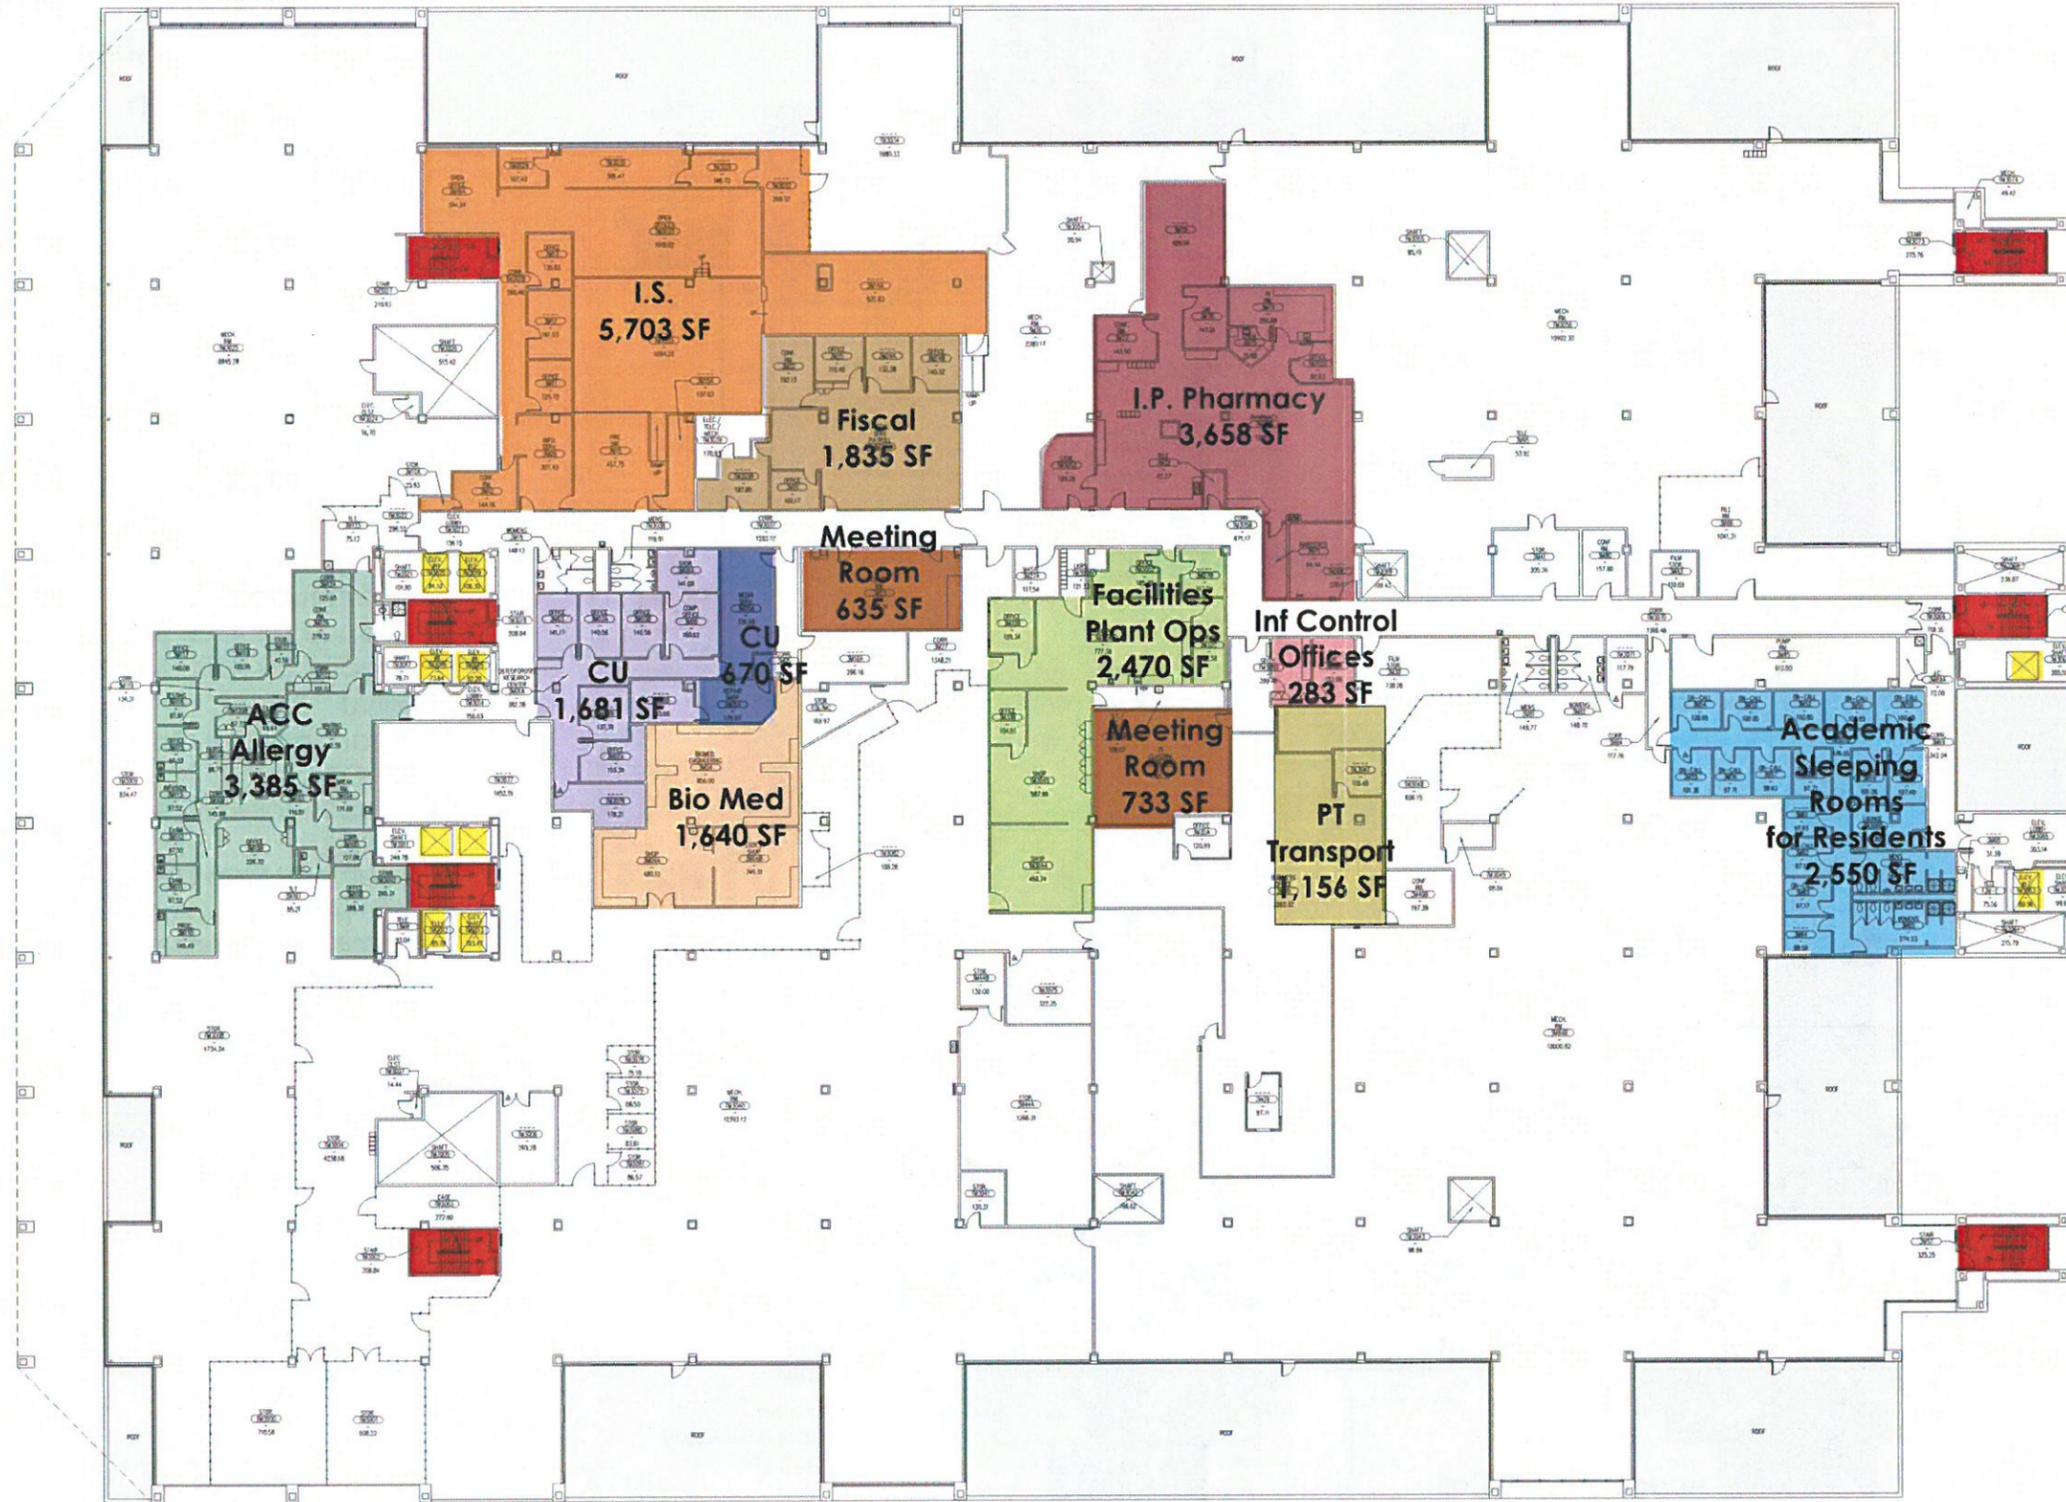
ACC Allergy	3,385 SF
I.S.	5,703 SF
Fiscal	1,835 SF
I.P. Pharmacy	3,658 SF
CU	1,681 SF
CU	670 SF
Bio Med	1,640 SF
Meeting Rooms	1,368 SF
Facilities Plant Ops	2,470 SF
Inf Control Offices	283 SF
PT Transport	1,156 SF
Academic Sleeping Rooms for Residents	2,550 SF

Total 26,399 SF
Misc. Circulation, Mech. & Exterior Wall **93,501 SF**
Total Gross 119,900 SF

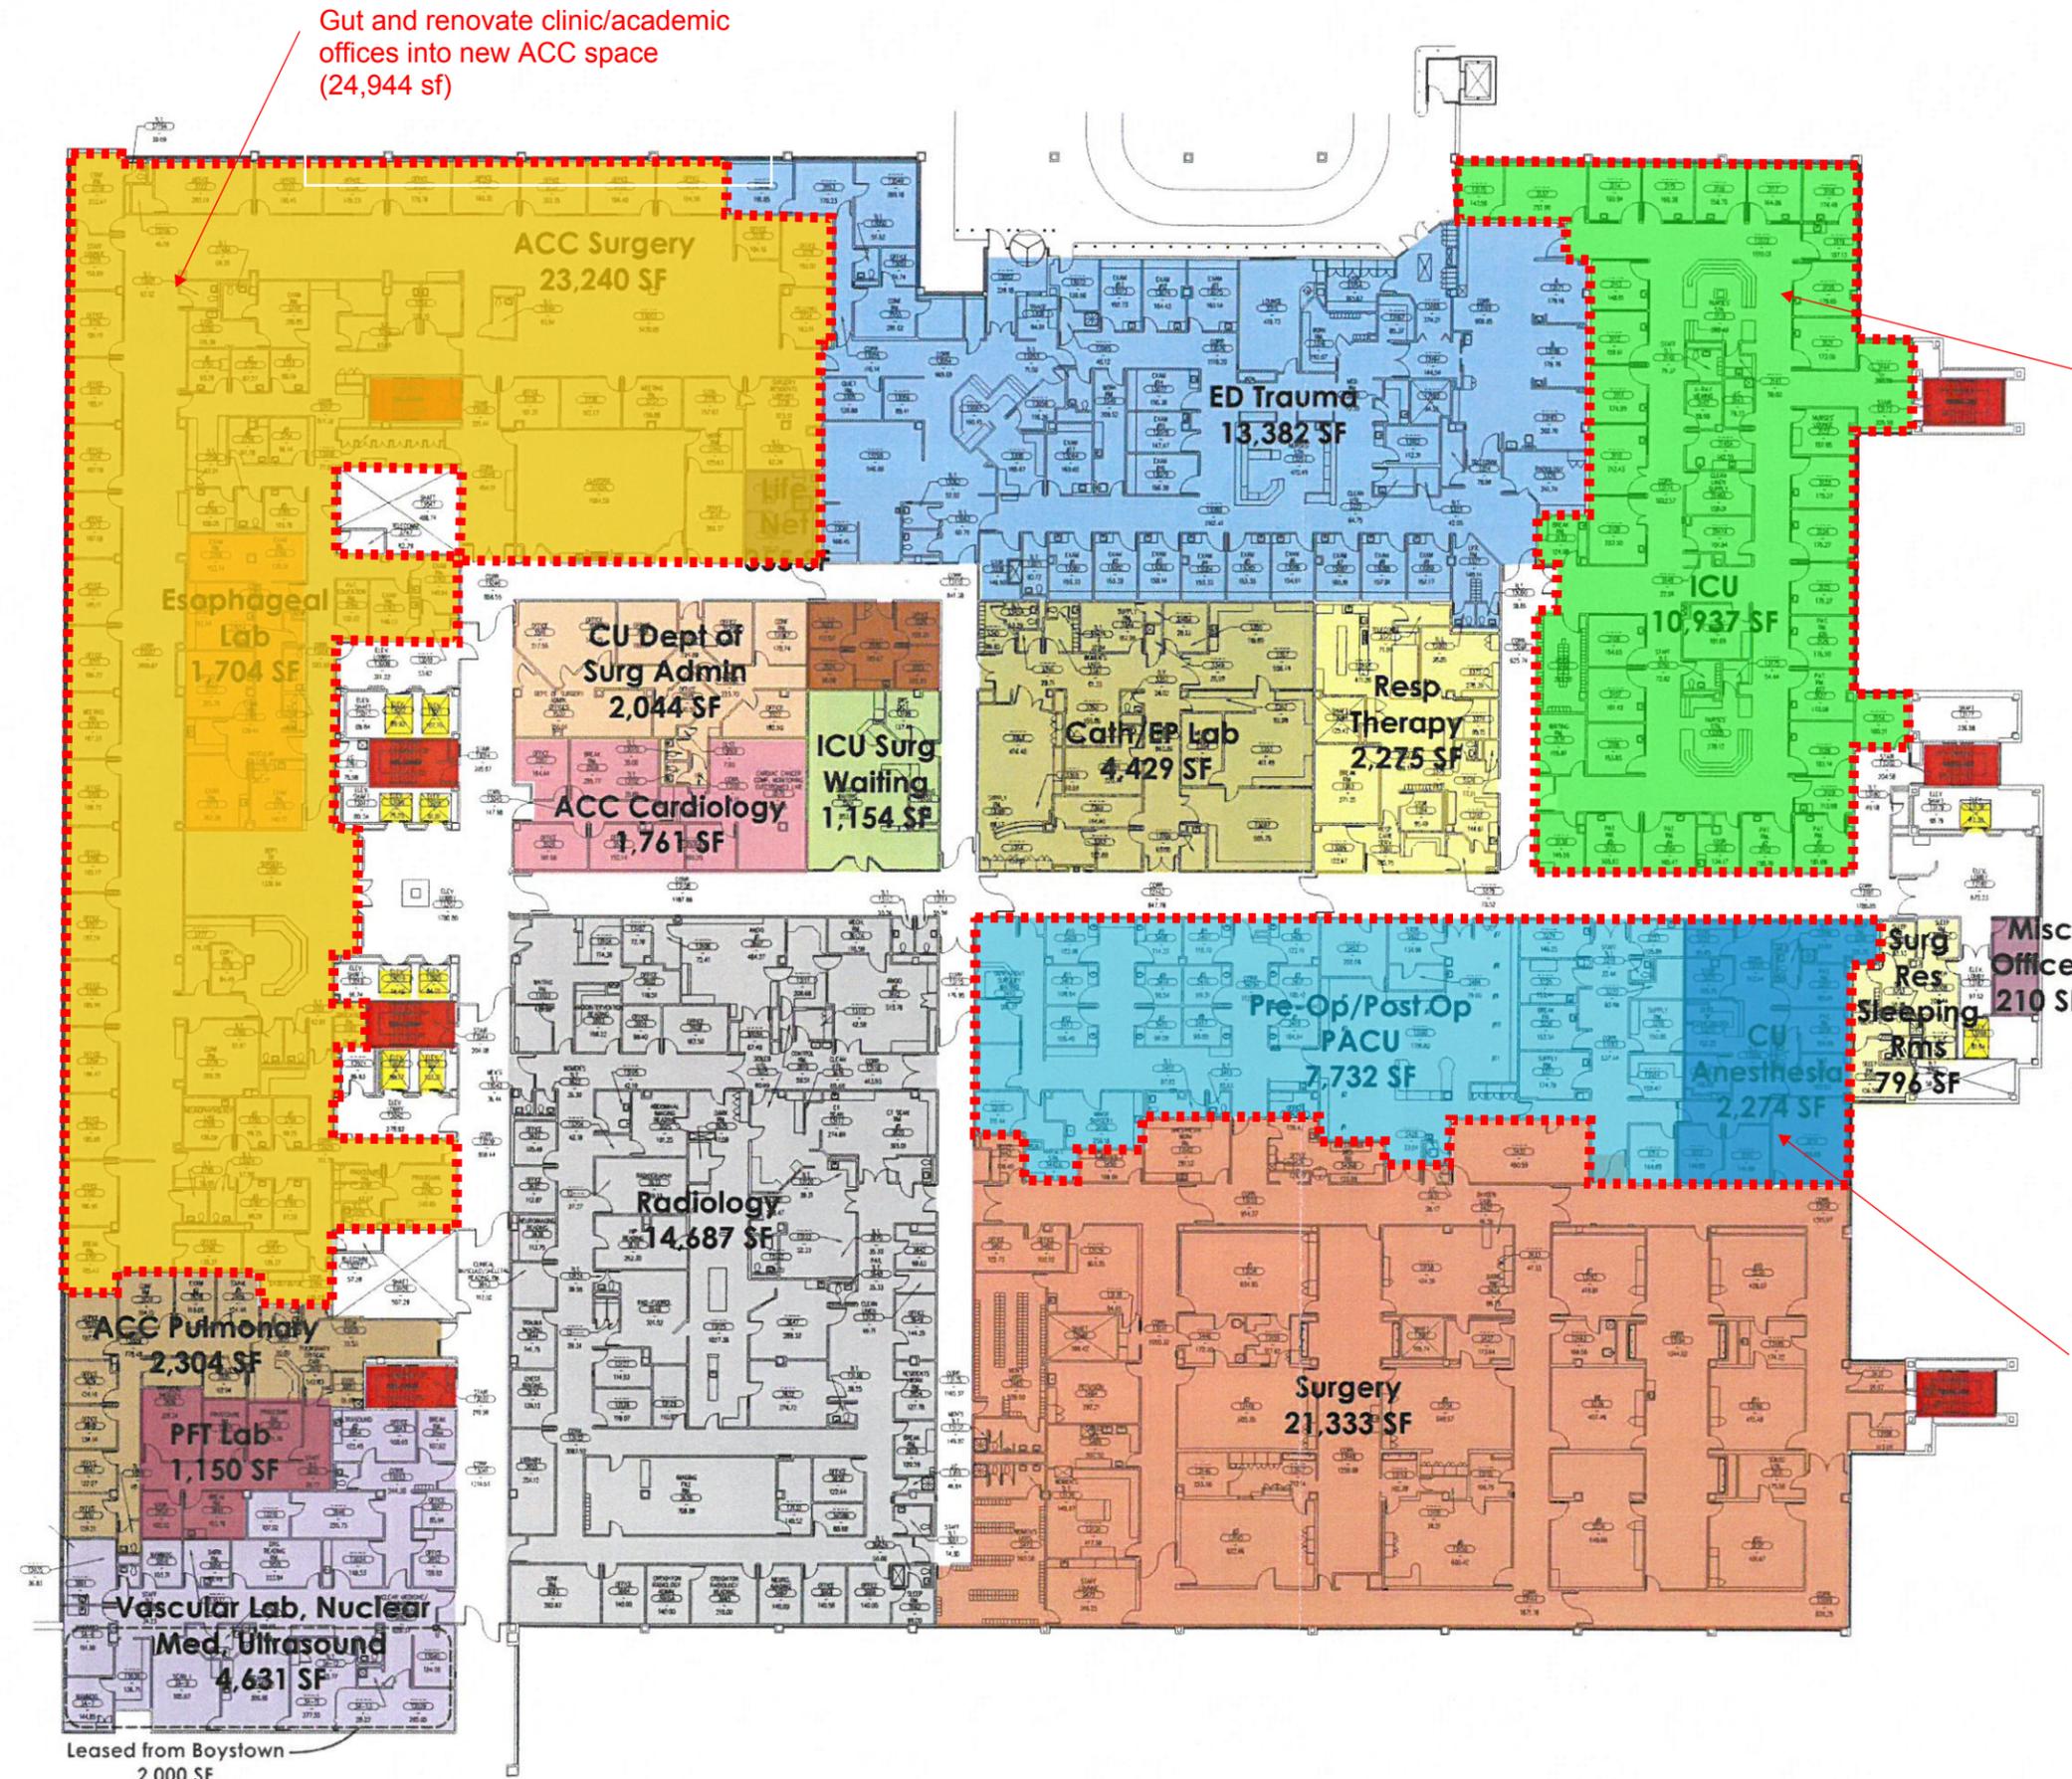
Gut and renovate existing ICU into new ICU with larger patient rooms (10,937 sf)

ACC Surgery	23,240 SF
Esophageal Lab	1,704 SF
ACC Pulmonary	2,304 SF
PFT Lab	1,150 SF
Vascular Lab, Nuclear Med, Ultrasound	4,631 SF
Life Net	355 SF
CU Dept of Surg Admin	2,044 SF
Ed/ Training	576 SF
ICU Surg Waiting	1,154 SF
ACC Cardiology	1,761 SF
Radiology	14,687 SF
ED Trauma	13,382 SF
Cath/EP Lab	4,429 SF
Resp Therapy	2,275 SF
ICU	10,937 SF
Pre-Op/Post Op, PACU	7,732 SF
Surgery	21,333 SF
CU Anesthesia	2,274 SF
Surg Res Sleeping Rms	796 SF
Misc Offices	210 SF

Total 116,974 SF
Misc. Circulation, Mech. & Exterior Wall **20,601 SF**
Total Gross 137,575 SF

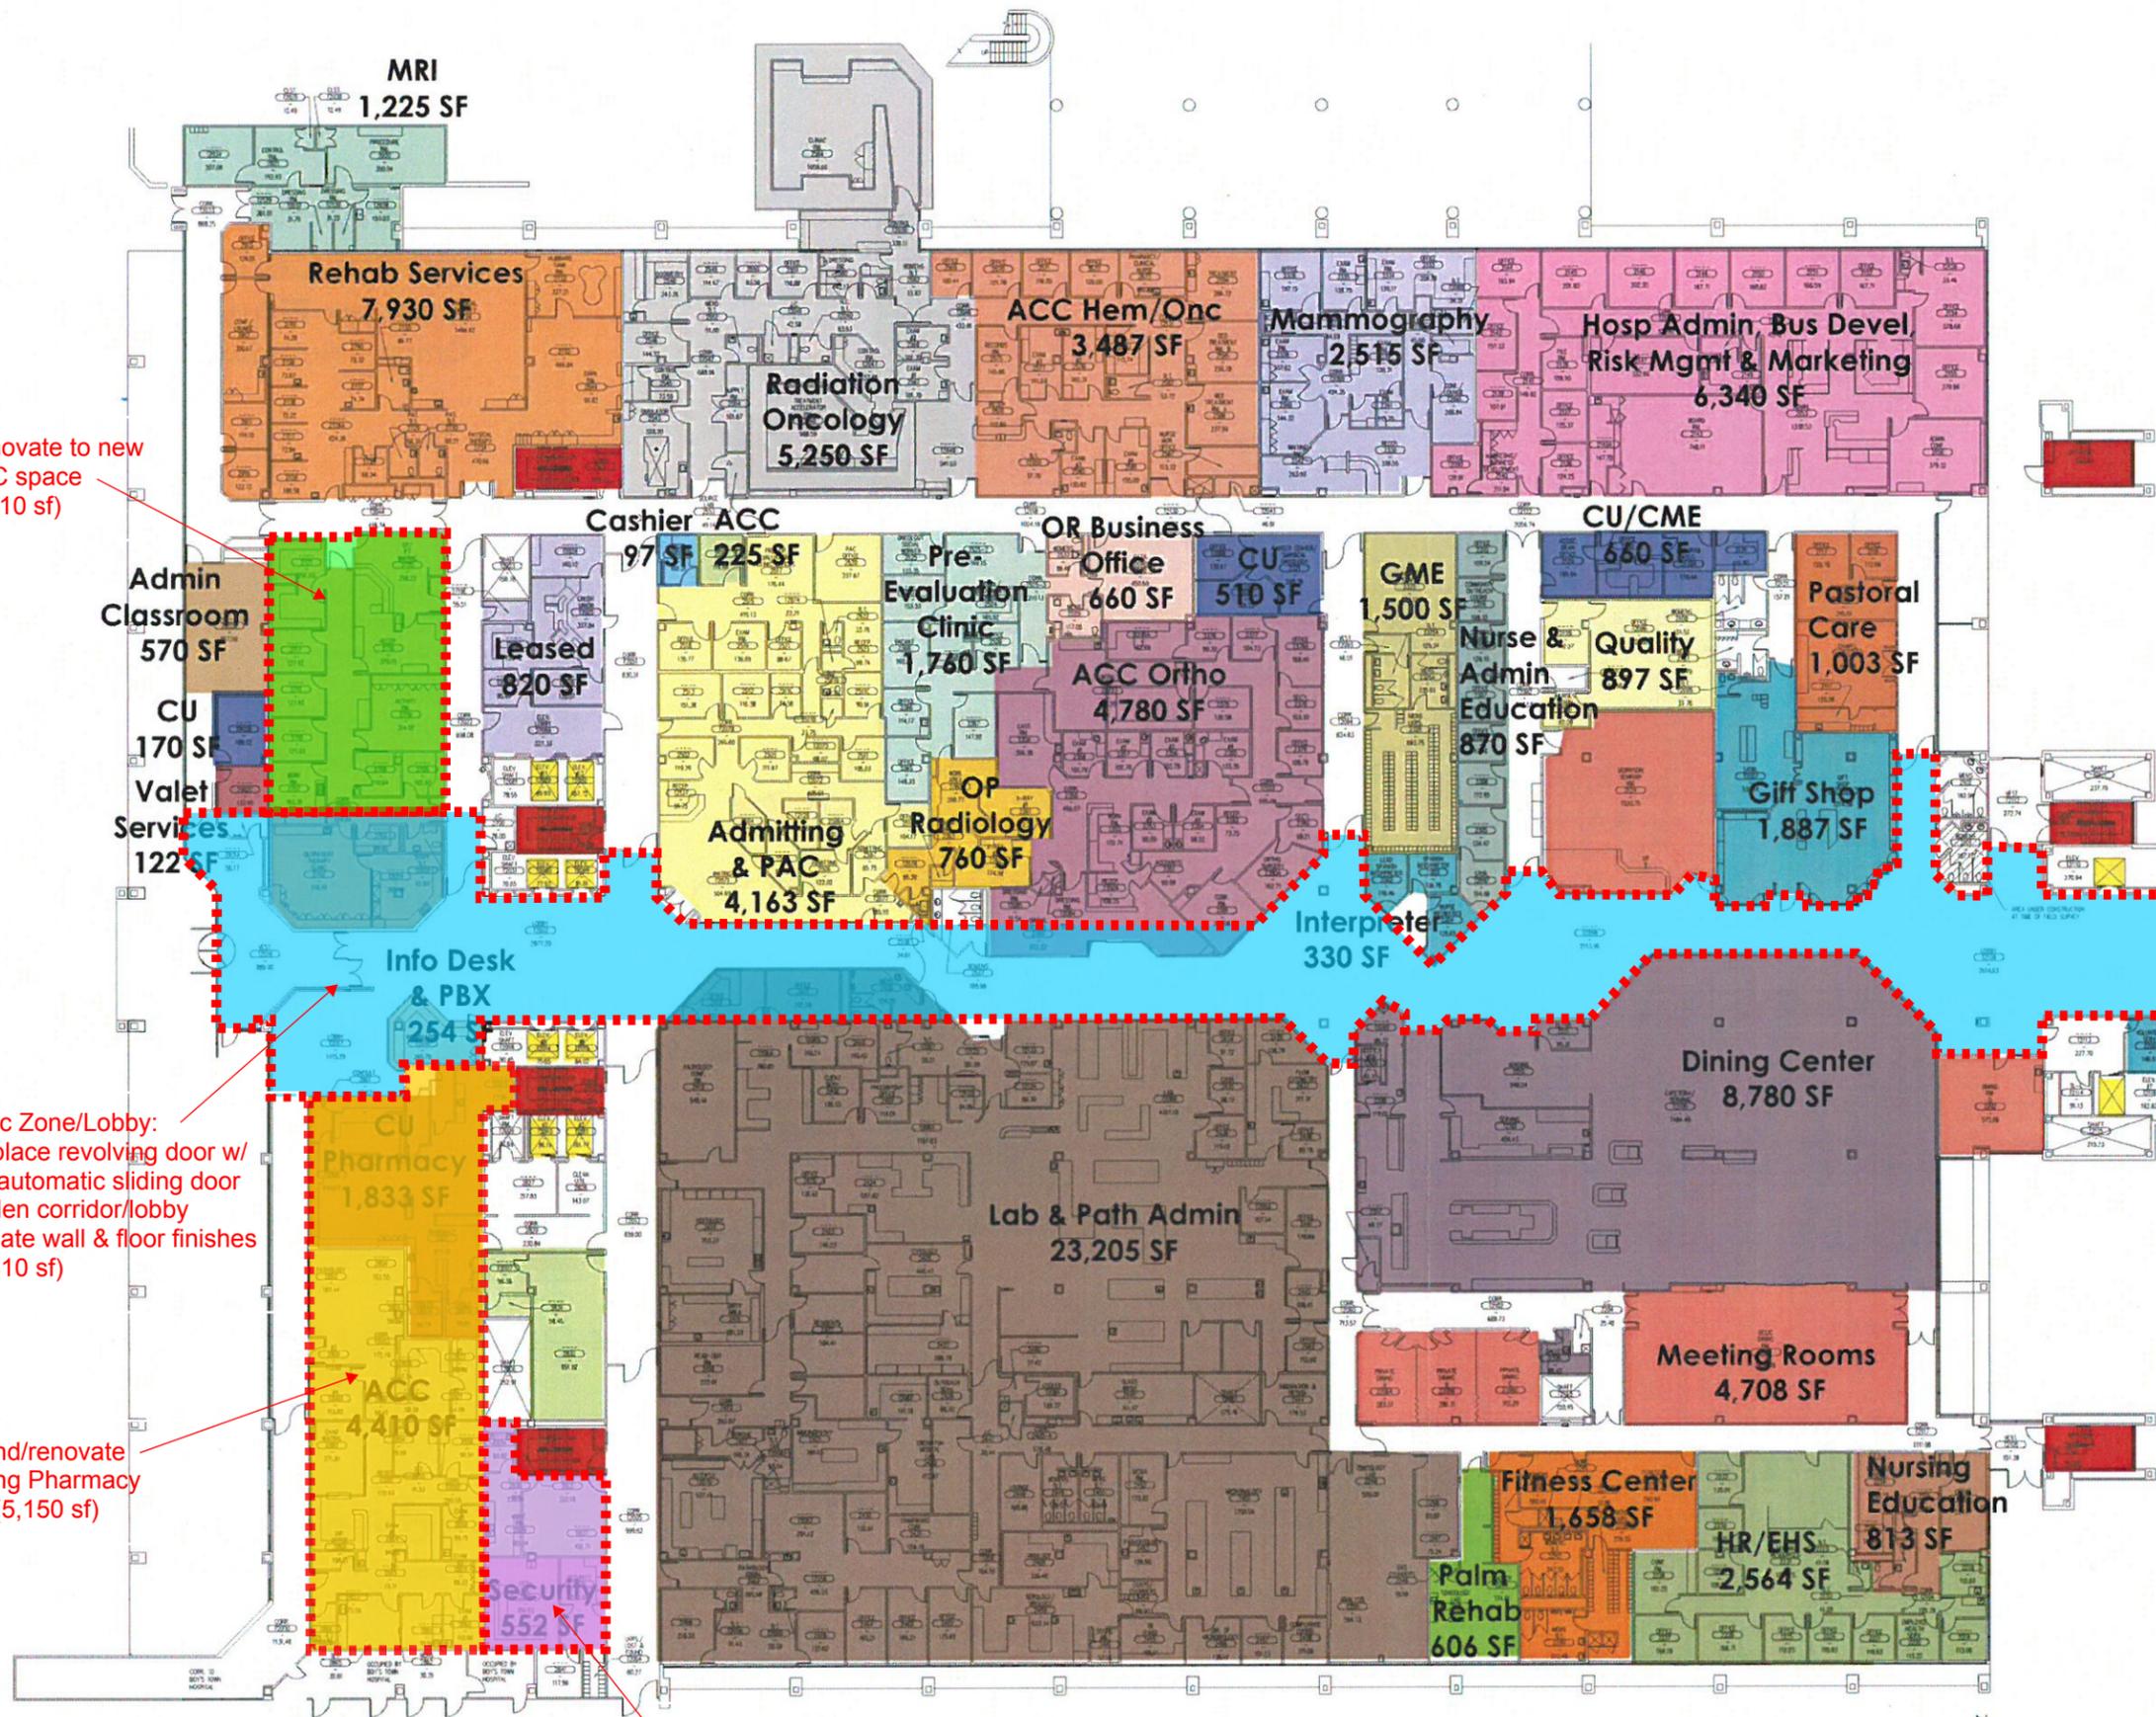
Renovate to new ACC space (2,510 sf)

Public Zone/Lobby:
- Replace revolving door w/ new automatic sliding door
- Widen corridor/lobby
- update wall & floor finishes (13,310 sf)
