**Department of Veteran Affairs
Omaha VA Hospitals Facility Condition Comparison**

Omaha, Nebraska

Omaha VA Hospitals Facility Condition Comparison

January 16, 2015

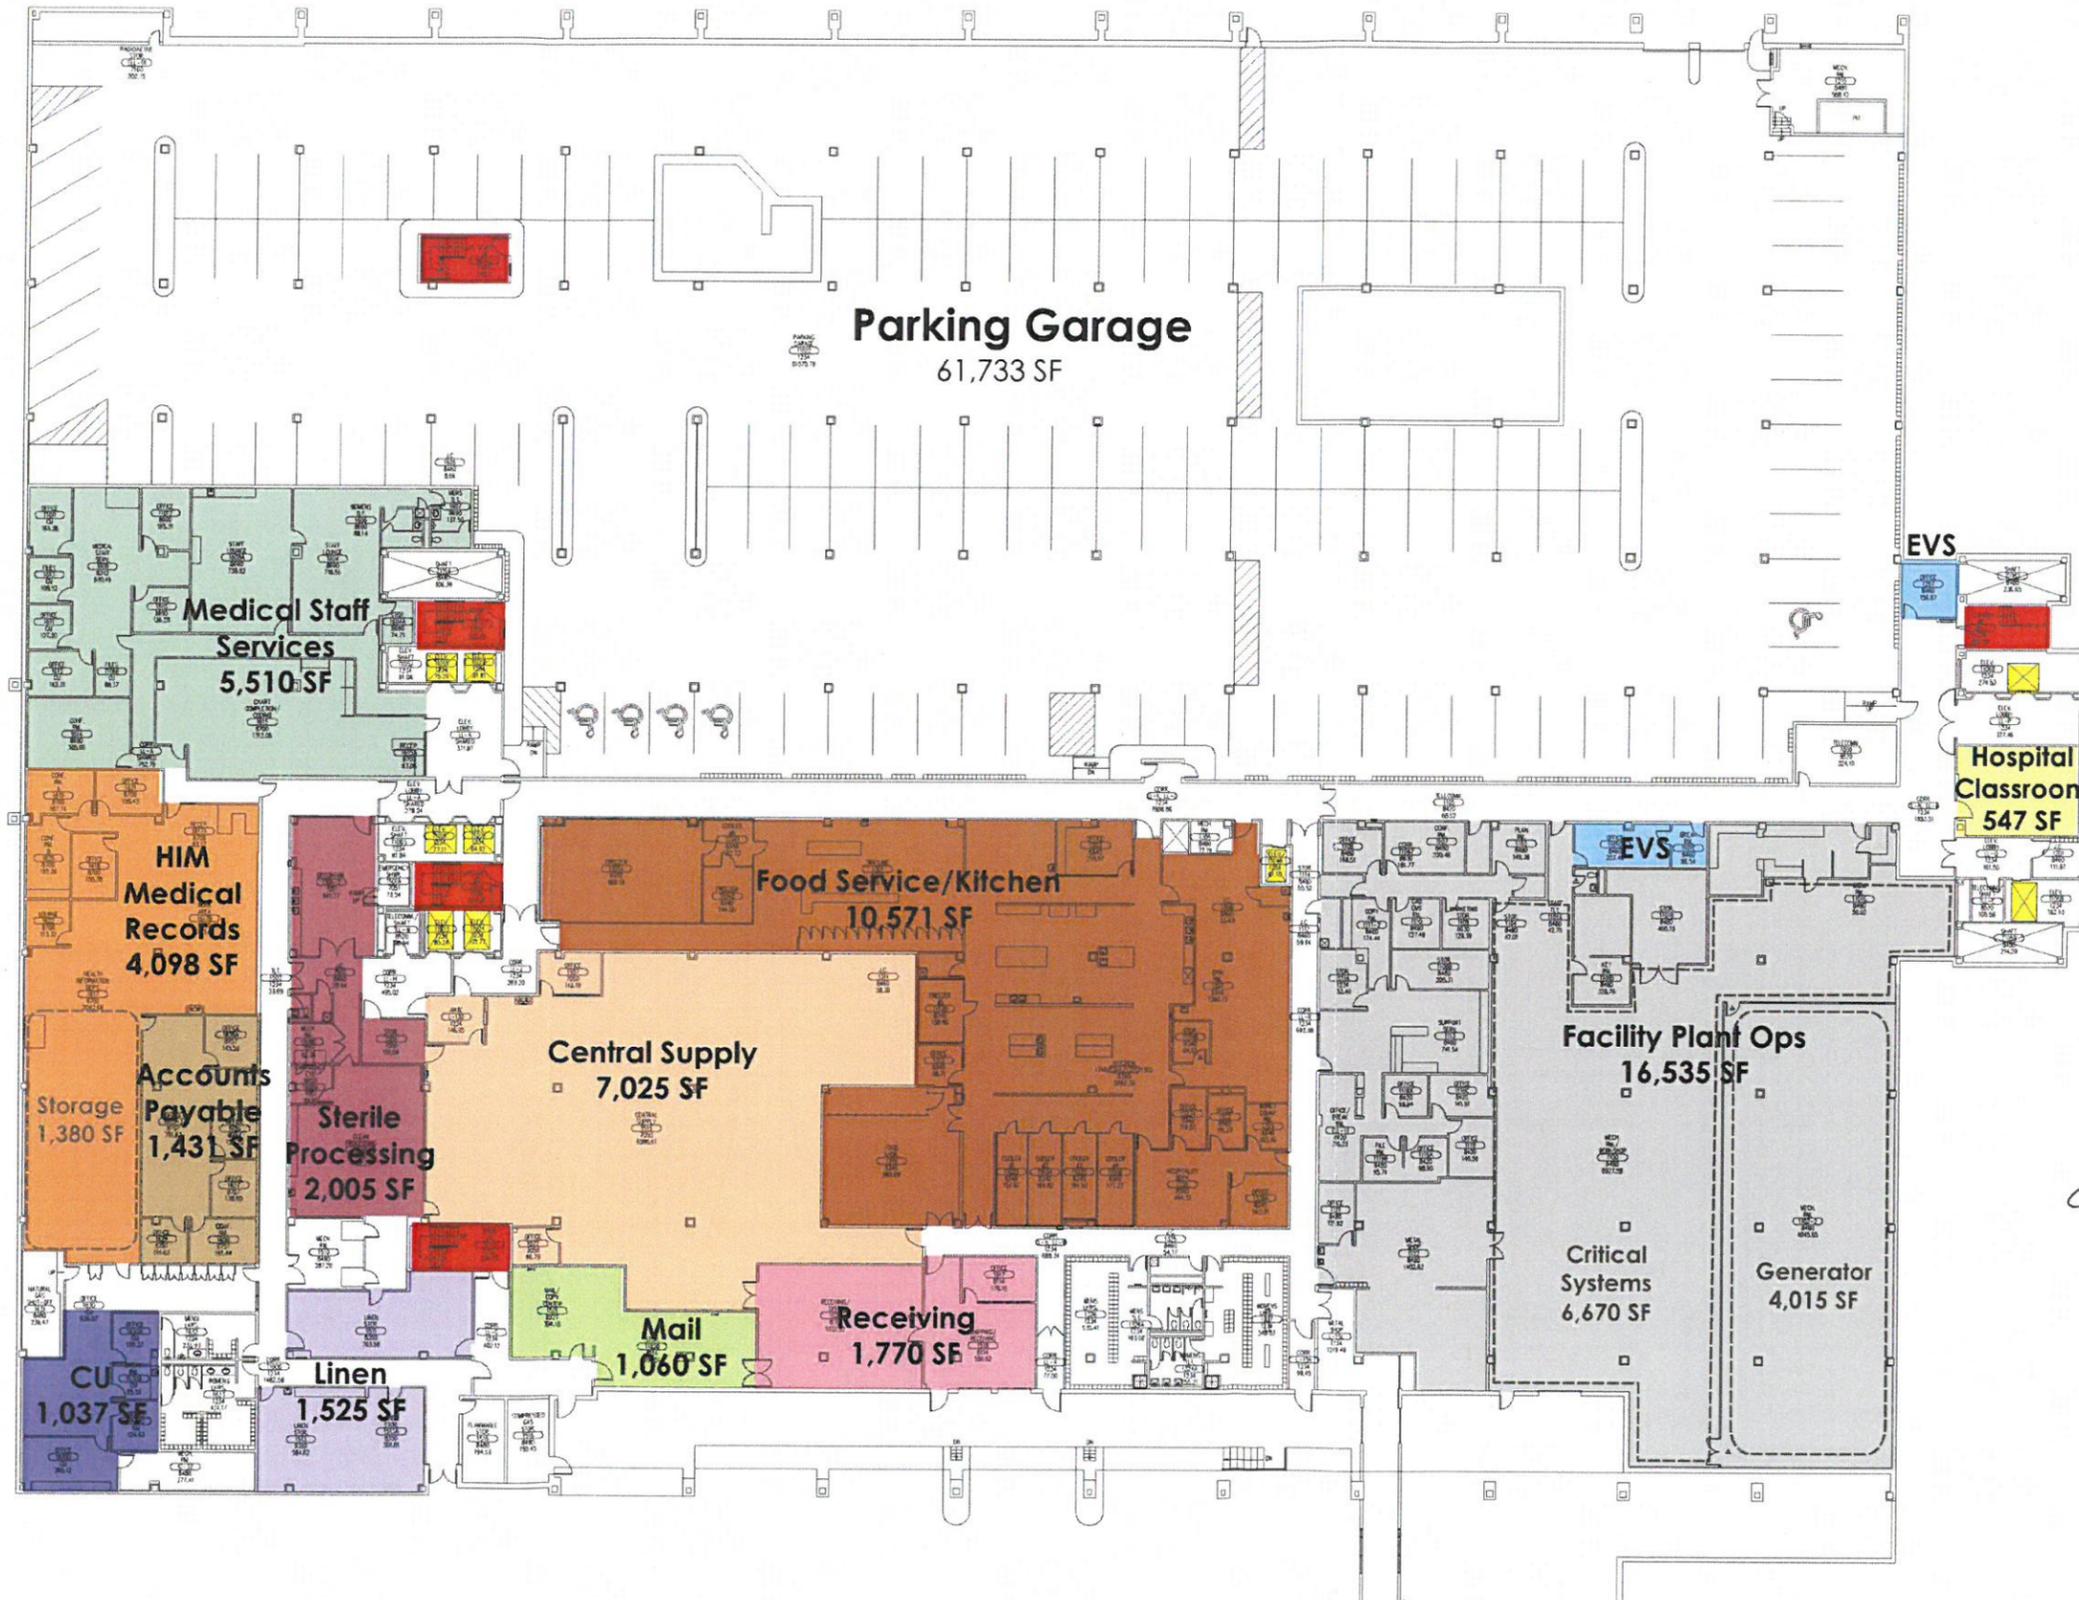
Medical Staff Services	5,510 SF
HIM Medical Records	4,098 SF
Accounts Payable	1,431 SF
Sterile Processing	2,005 SF
Linen	1,525 SF
CU	1,037 SF
Central Supply	7,025 SF
Food Service/Kitchen	10,571 SF
Mail	1,060 SF
Receiving	1,770 SF
Facility Plant Ops	16,535 SF
EVS	436 SF
Hospital Classroom	547 SF

Total 53,550 SF
 Misc. Circulation, Mech. & Exterior Wall **20,472 SF**
Total Gross 74,022 SF
